Manhole Inspection Summary

Manhole # S13U__007MH

Insp Date: **3/17/08 8:36 AM**

Location Address: **1018 Benson Cowan**

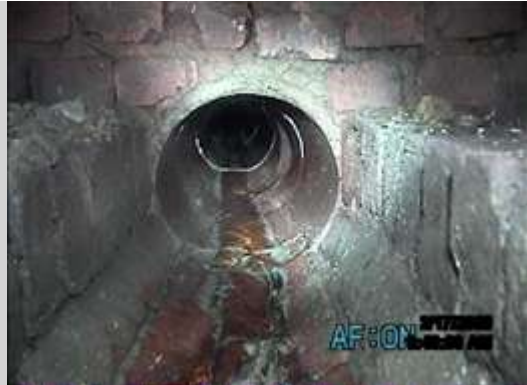
12 O'Clock Outflow

Pipe Height: **8.4** (in.) Rod and Bar (Angled)
Pipe Material: **Clay** ☐ Pipe Lined
Invert Depth: **7.96** (ft.) Flow Characteristics: **Slow**
Deposits: ☒ None ☐ Mud ☐ Sludge ☐ Debris ☐ Grease
Silt Depth: **0** (in.) Deposits Extent:
Infiltration: **None** Pipe Seal Cond: **Sound**

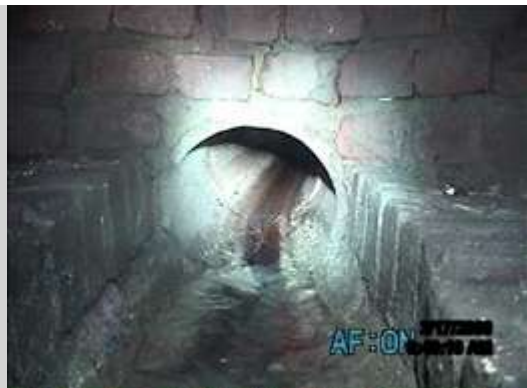
5 O'Clock Inflow

Pipe Height: **8.4** (in.) Rod and Bar (Angled)
Pipe Material: **Clay** ☐ Pipe Lined
Invert Depth: **7.94** (ft.) Flow Characteristics: **Slow**
Deposits: ☒ None ☐ Mud ☐ Sludge ☐ Debris ☐ Grease
Silt Depth: **0** (in.) Deposits Extent:
Infiltration: **None** Pipe Seal Cond: **Sound**
